**WHITE PAPER
GRANT PF-260799-18
EVERGREENS ENVIRONMENTAL IMPROVEMENTS**

EMILY DICKINSON MUSEUM

JANUARY 31, 2024

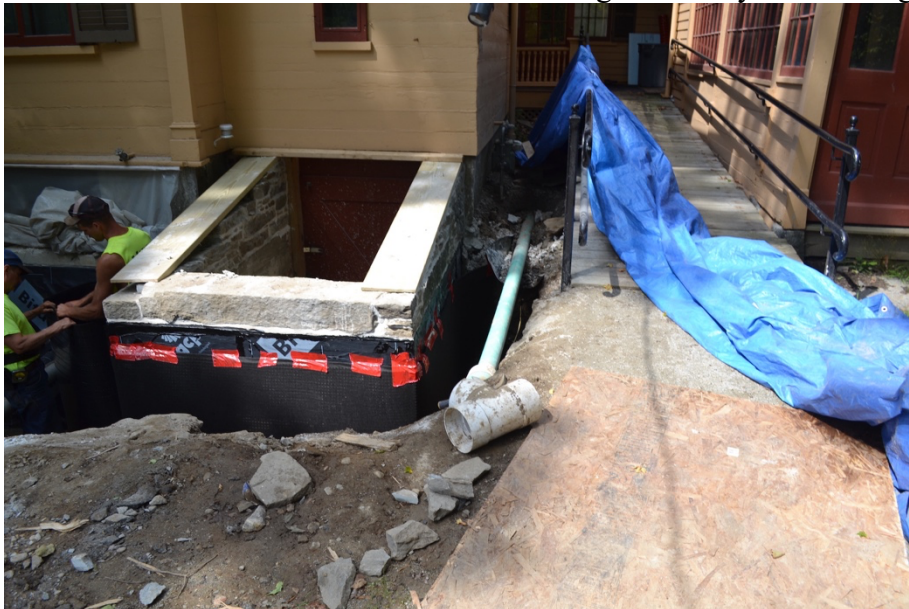
Analysis: The Evergreens has experienced chronic issues with water entry through the north and east foundation walls and inadequate roof drainage directly above the north foundation wall. Surface water runoff on the northeast side of the house, soil saturation, and clay soils compound moisture problems.

Figure 1: Rebuilt basement bulkhead next to drainage assembly for rebuilt gutter.

Recommendation and actions taken: Reconstruct the pitch and capacity of the gutter on the north roof to prevent overflow to the foundation wall below. Reconstruct the basement bulkhead entry and provide footing drainage to deter water flows.

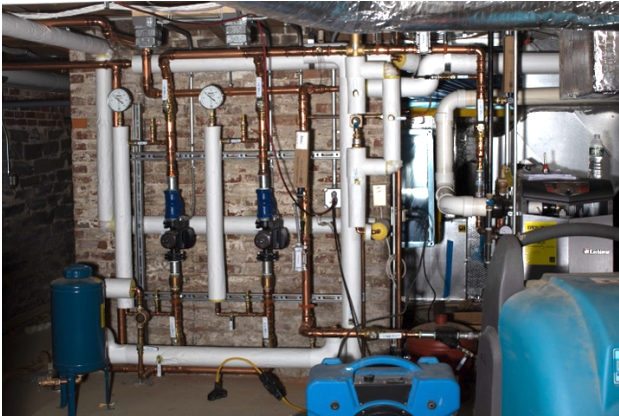
Figure 4 (left): Heat pump and boiler assembly in basement.

Actions taken: The new HVAC system as installed provides even distribution of conditioned air through new ducts while utilizing low air volume to avoid drafts. Two new AHUs (air handling units) are located in the basement and two new condensing units are located outside the building. A VRF (variable refrigerant flow) heat pump is supplemented by a high-efficiency boiler as a back-up in extremely low temperatures and delivers conditioned air through new low-leakage flanged and insulated ductwork. A centrally managed BMS (building management system with temperature and relative humidity recordkeeping enable a continuous commissioning process. The HVAC system design also includes reheat for the purpose of reducing summer-time excess humidity. The two air handling systems (heat pump and boiler) are configured with hot water heating coils down-stream from the cooling coils. The BMS will control the cooling and reheat coils to achieve both the temperature and indoor humidity set points. The system provides continuous circulation of air to filter and homogenize conditions and to avoid stagnant pockets of air that may lead to undesirable micro-climates. The filtration levels are designed to be MERV 13 or better as recommended by consulting conservators.

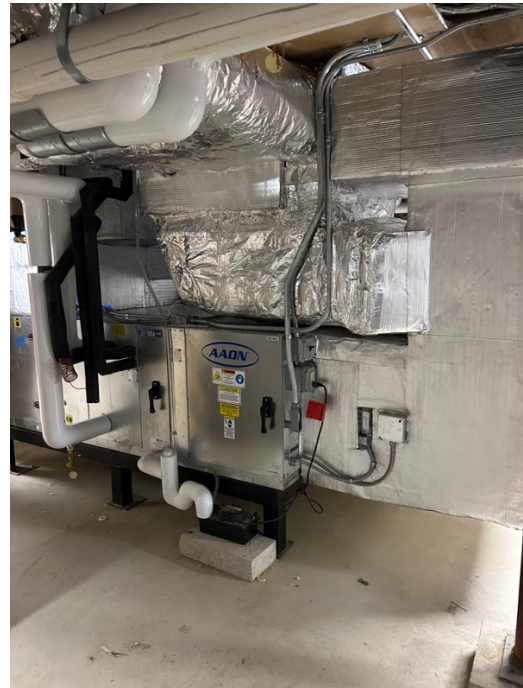
Figure 5 (right): New air handling unit in basement
